Fire Sprinkler System  
Corrosion / MIC Inspection Report

DEF Company

123 Any St  
Denver, CO

Date: January 1, 2014

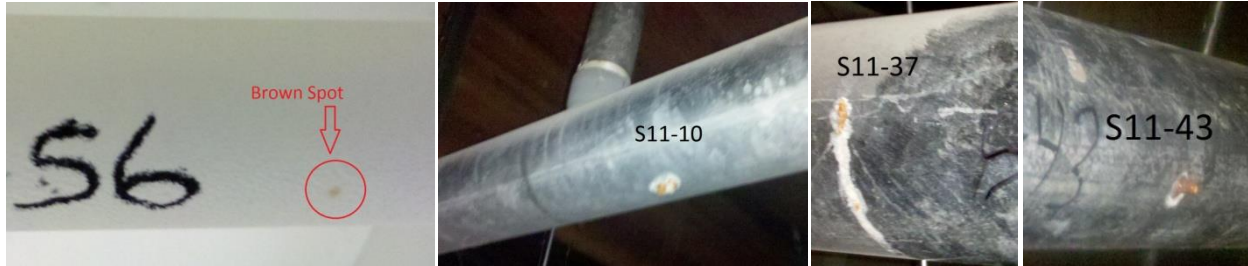
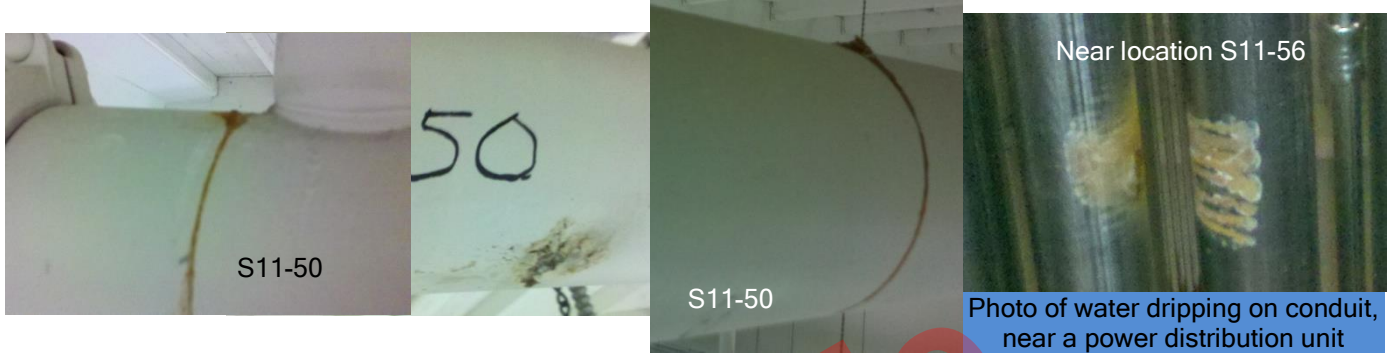
Photos of seepage points discovered

1. Several new leaks were discovered and immediately brought to the attention of ABC personnel. These areas are indicated by a **rust colored oval** on the drawings. Almost all of these previously undiscovered leaks were located directly over customer server racks, switches, and facility power distribution equipment (see picture of water dripping on power distribution conduit).

SoniTech NDT cannot make a judgment as to replacement, however, it is recommended that existing leaks be repaired immediately and the worst of the remaining locations be removed and carefully examined as to the exact nature and extent of corrosive damage. If the corrosion is found to be significant enough to warrant replacement, then consideration should be given to treating the new system with a chemical MIC inhibitor to prevent or inhibit further corrosive activity.

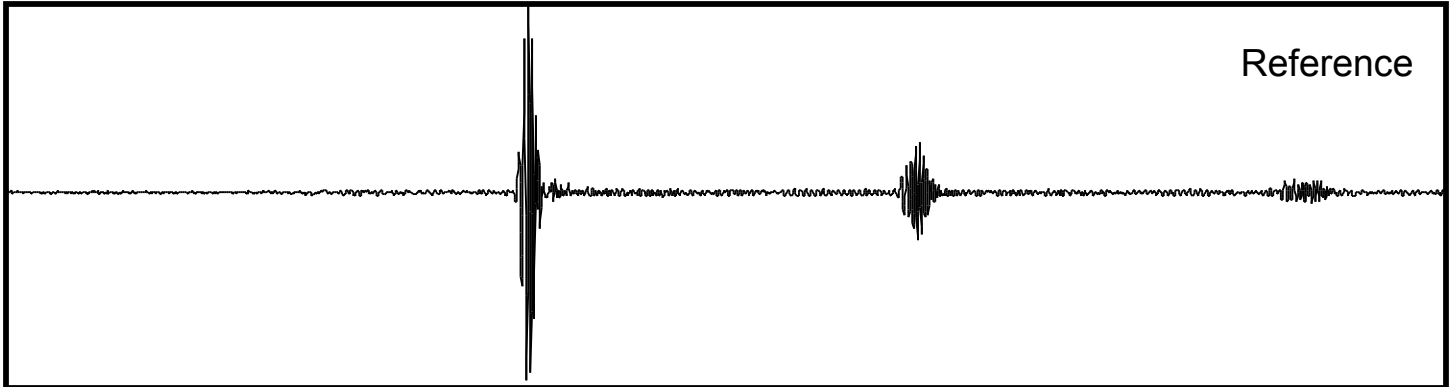
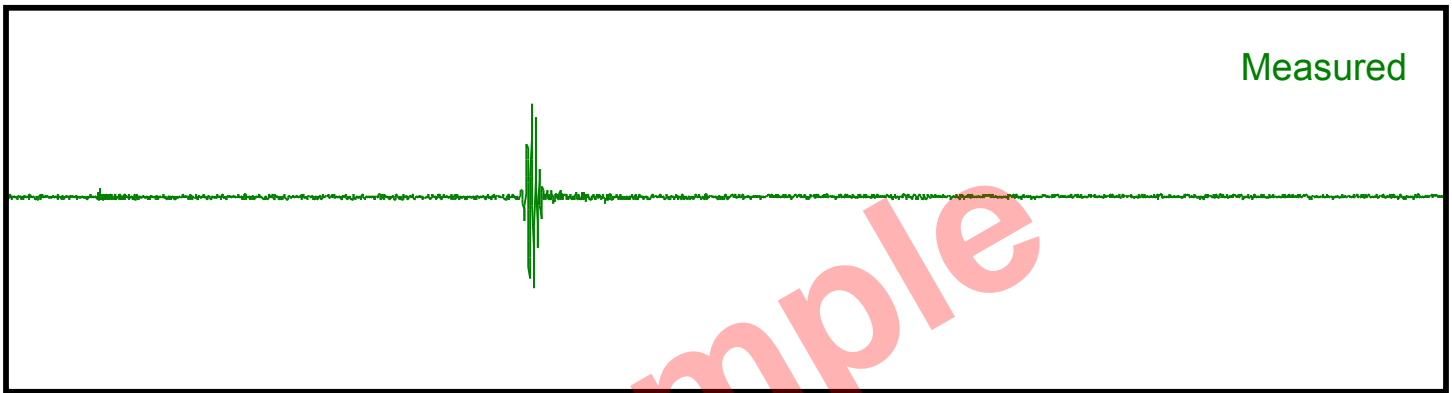
Location: 8

Example of a bad dry 4" schedule 10 pipe

Minimum Thickness: 0.091 in.

Maximum Wall Loss: 24.17 %

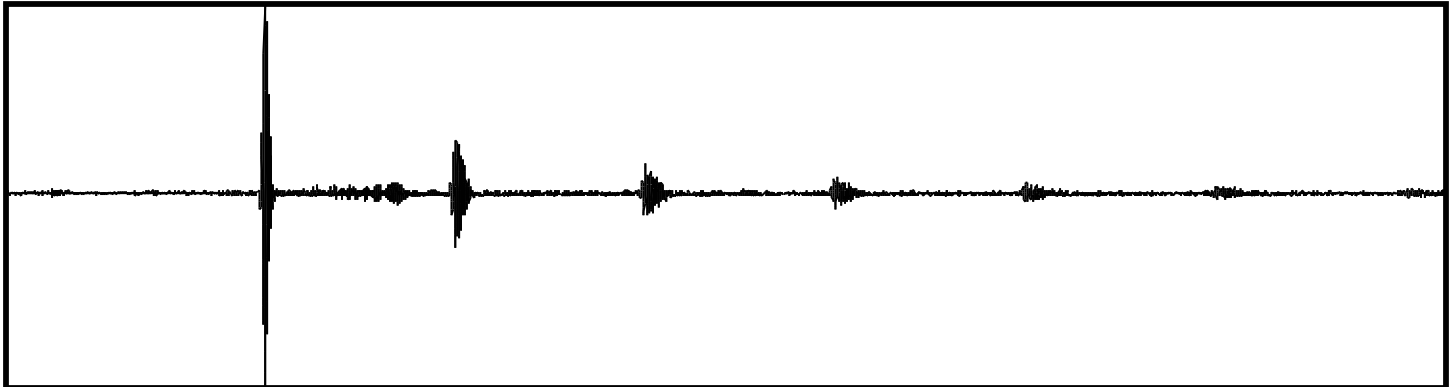
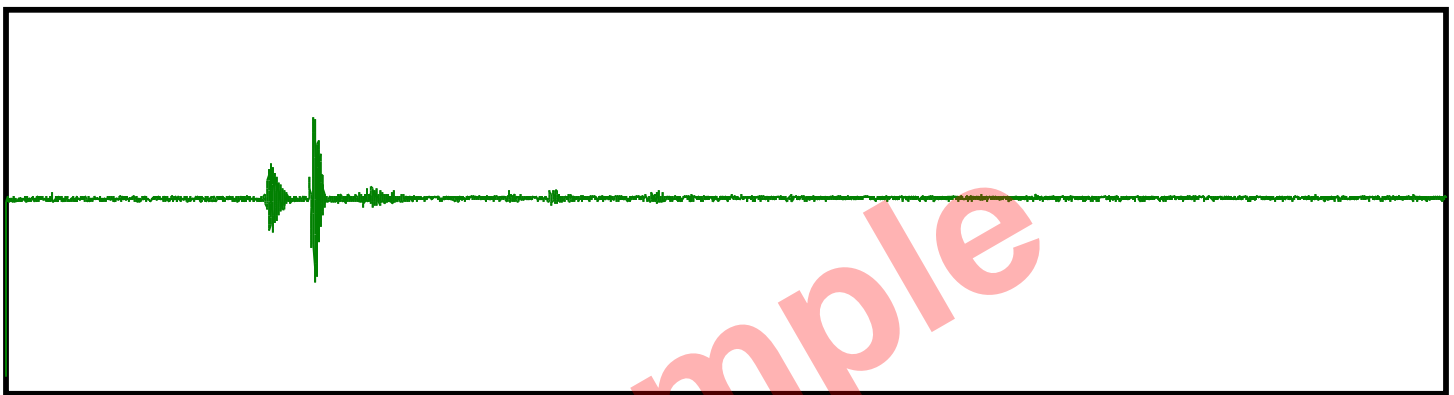
Location: 1

Example of a moderately bad dry 4" schedule 10 pipe with trapped water

Minimum Thickness: 0.109 in.  
Maximum Wall Loss: 9.17 %

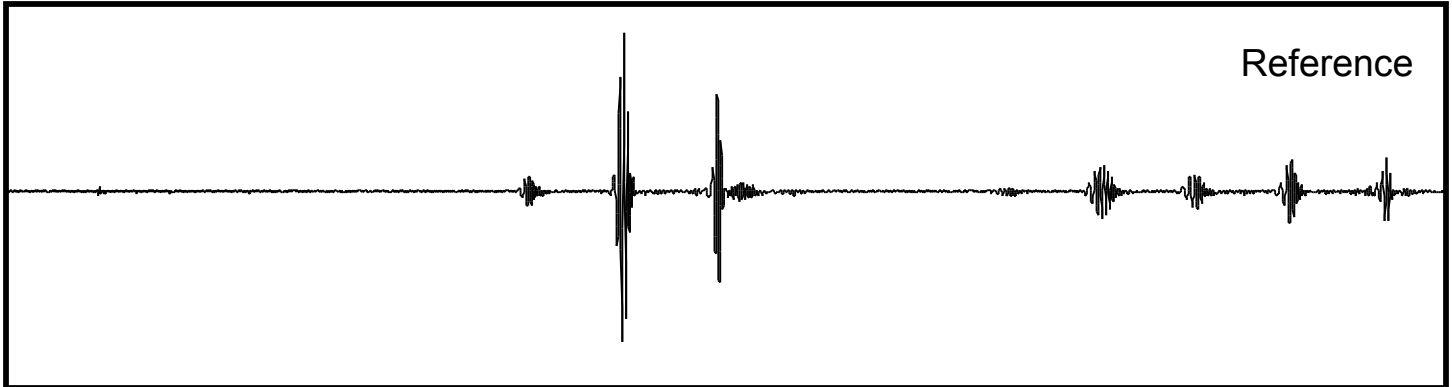
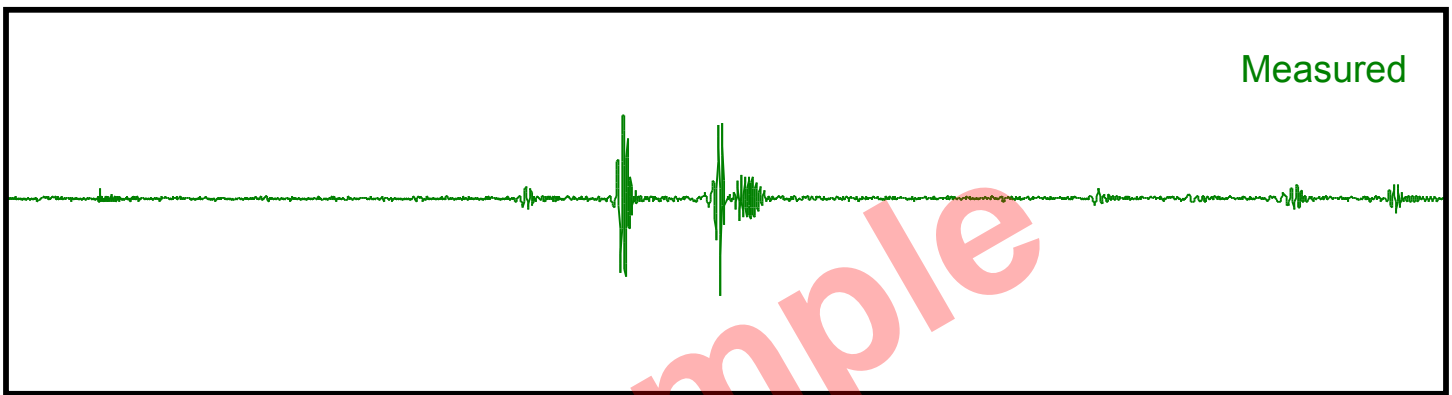
Location: 1

Example of a moderately bad wet 4" schedule 10 pipe

Minimum Thickness: 0.114 in.

Maximum Wall Loss: 5.00 %

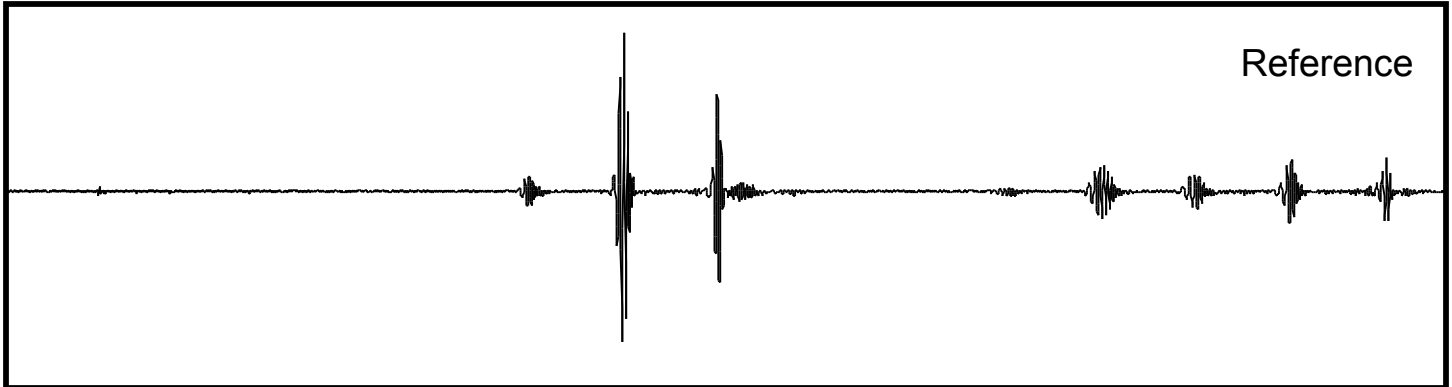
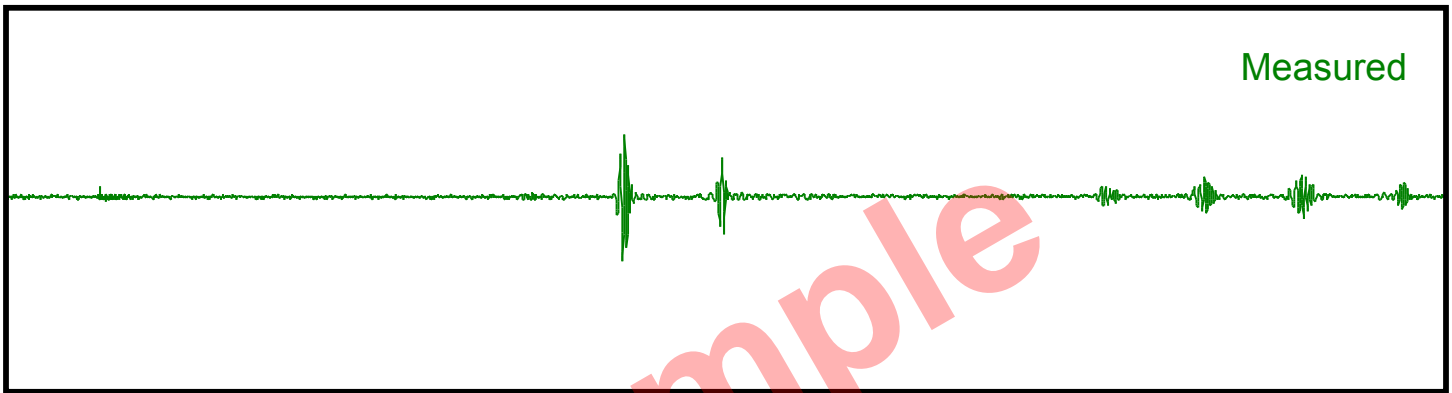
Location: 5

Example of a bad wet 4" schedule 10 pipe

Minimum Thickness: 0.093 in.

Maximum Wall Loss: 22.50 %

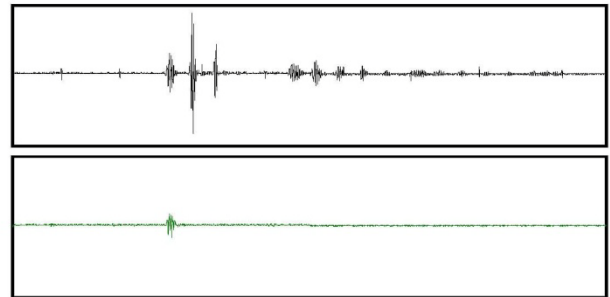
File Name:  
**Location: 75**  
Diameter: 2.5  
Schedule: 10  
System Type: WET  
Nominal Thickness: 0.12

Average Thickness: 0.108 in.  
Average Wall Loss: 10.28%  
Maximum Wall Loss: 13.33%

Example on right represents corroded pipe
